# Collapse Assessment of the ACC Building

### ASCE 41 Evaluation Utilizing Nonlinear Response History Analyses of a 1965 Reinforced Concrete Building

**Kevin S. Moore, S.E.**  
M Engineering

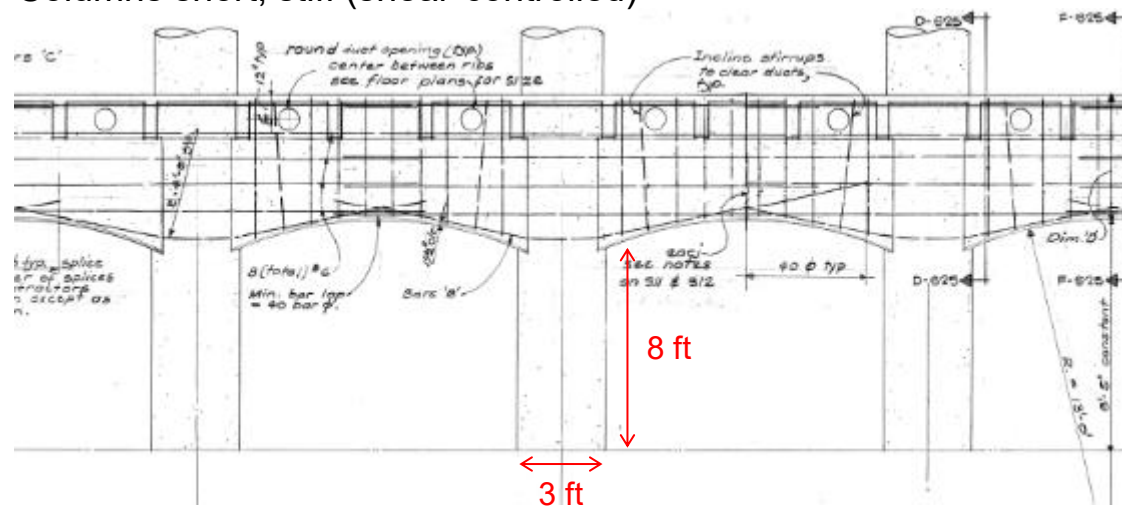
Columns short, stiff (shear-controlled)

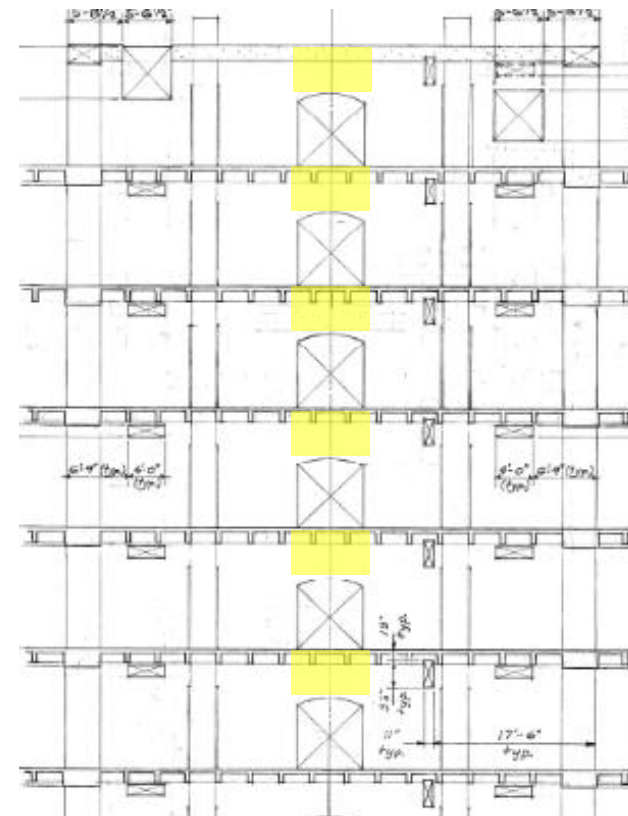
Tower core wall with large openings

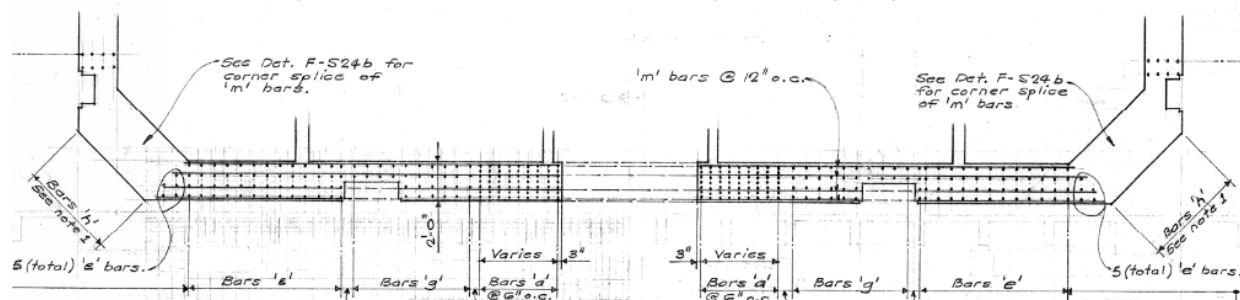
Core wall heavily reinforced, but incredibly thick (2 ft)

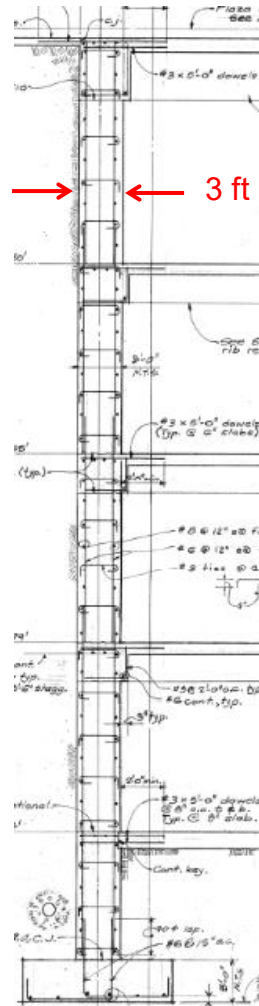
Thick perimeter walls  
in garage levels

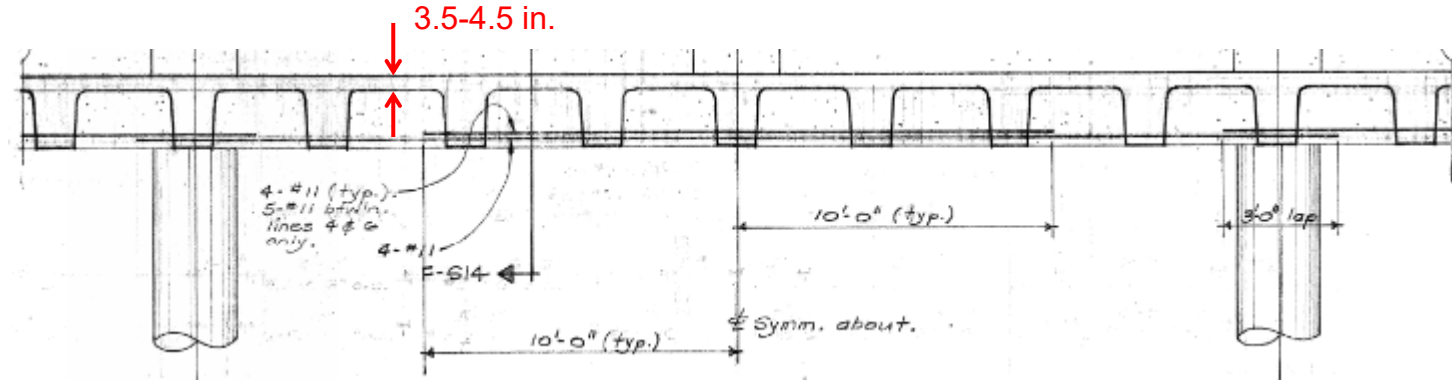
Thin diaphragm slab part of cast joist floor framing/system

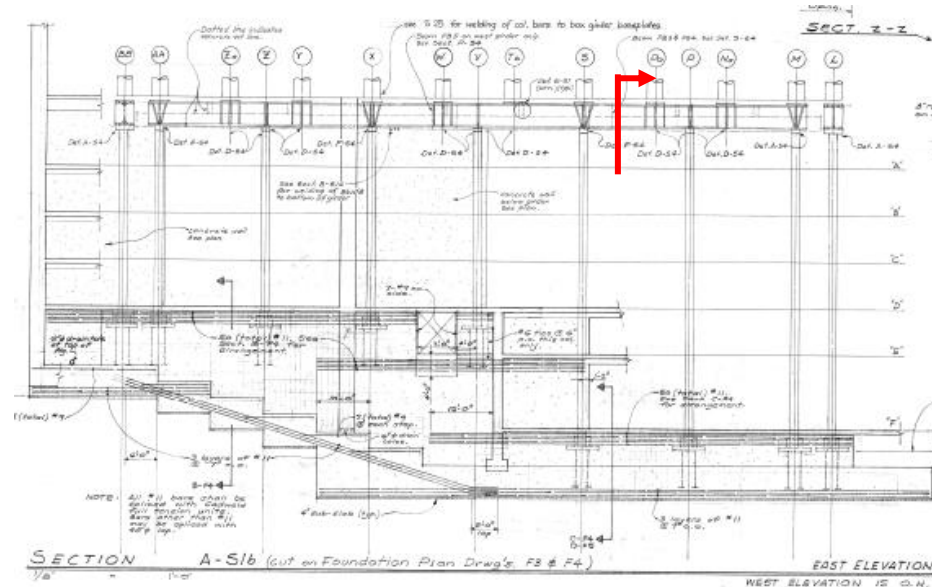
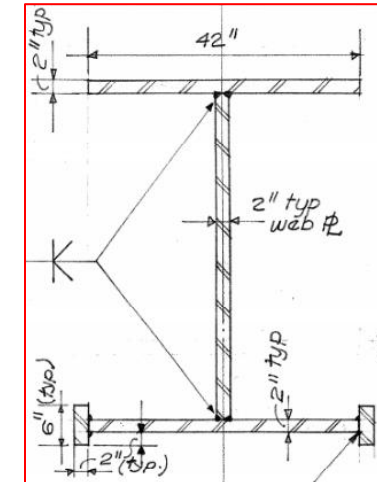
Support at bottom of tower columns close to capacity.

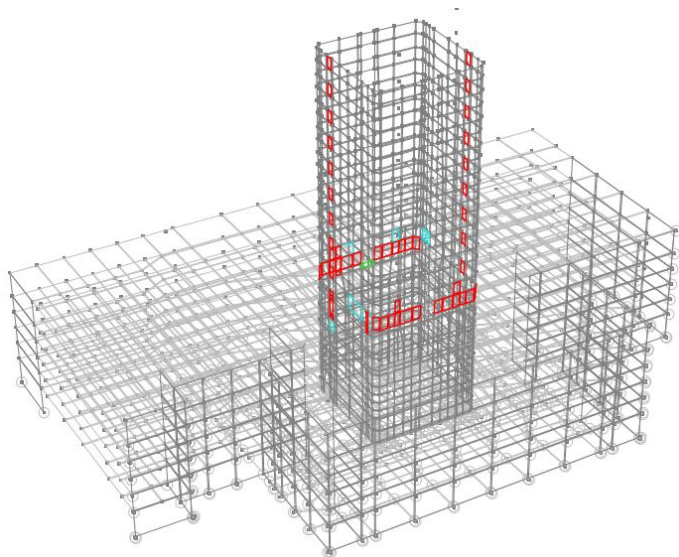
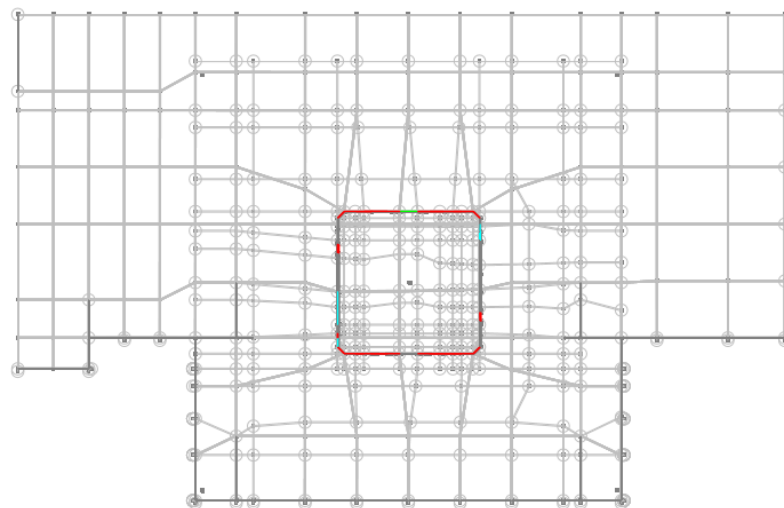
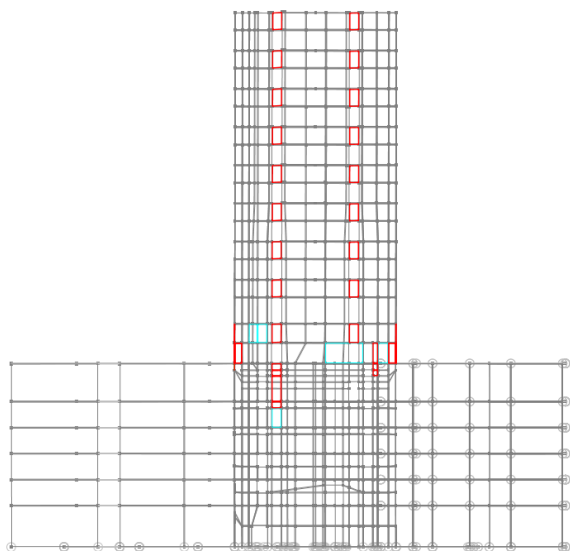
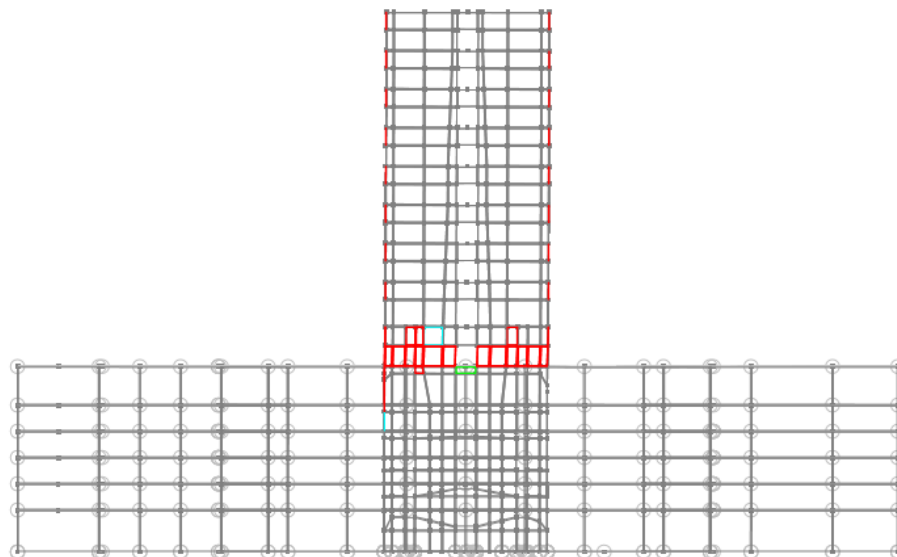
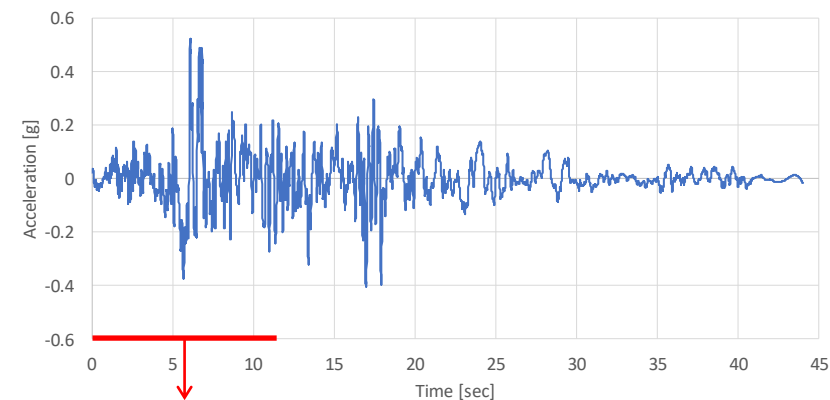
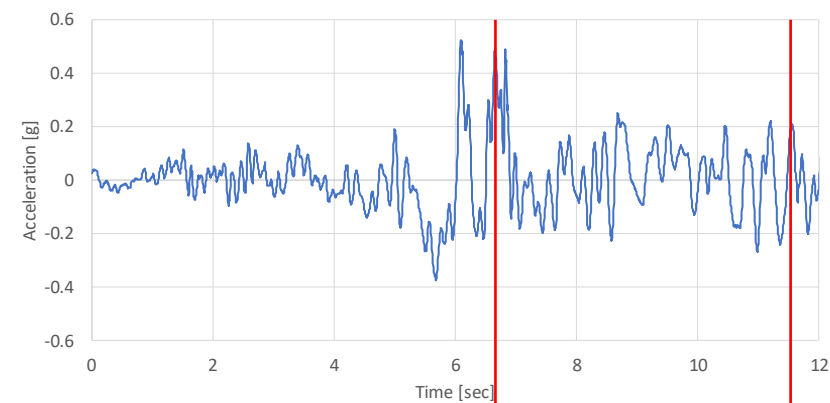
Tower coupling beams fail

Base of tower core fails
