# Collapse Assessment of the ACC Building

### ASCE 41 Evaluation Utilizing Nonlinear Response History Analyses of a 1965 Reinforced Concrete Building

**Kevin S. Moore, S.E.**  
M Engineering

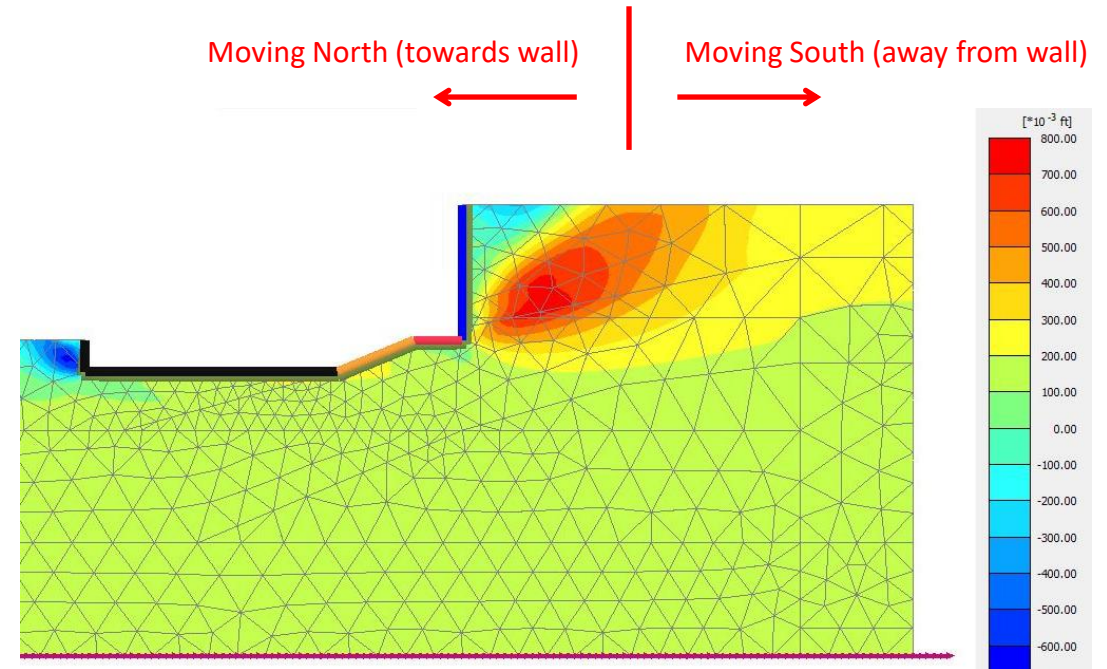
- Ground motion reduced near wall
  - Apply varying ground motions from SSI model to nonlinear structural model to capture benefit of reduced demand.
- Soil behind wall expected to form failure plane during seismic event.
  - Potential to fill into gap formed as wall moves North (away from soil).
  - May cause ratcheting displacements.
  - Need to evaluate time history response of wall to assess ratcheting.

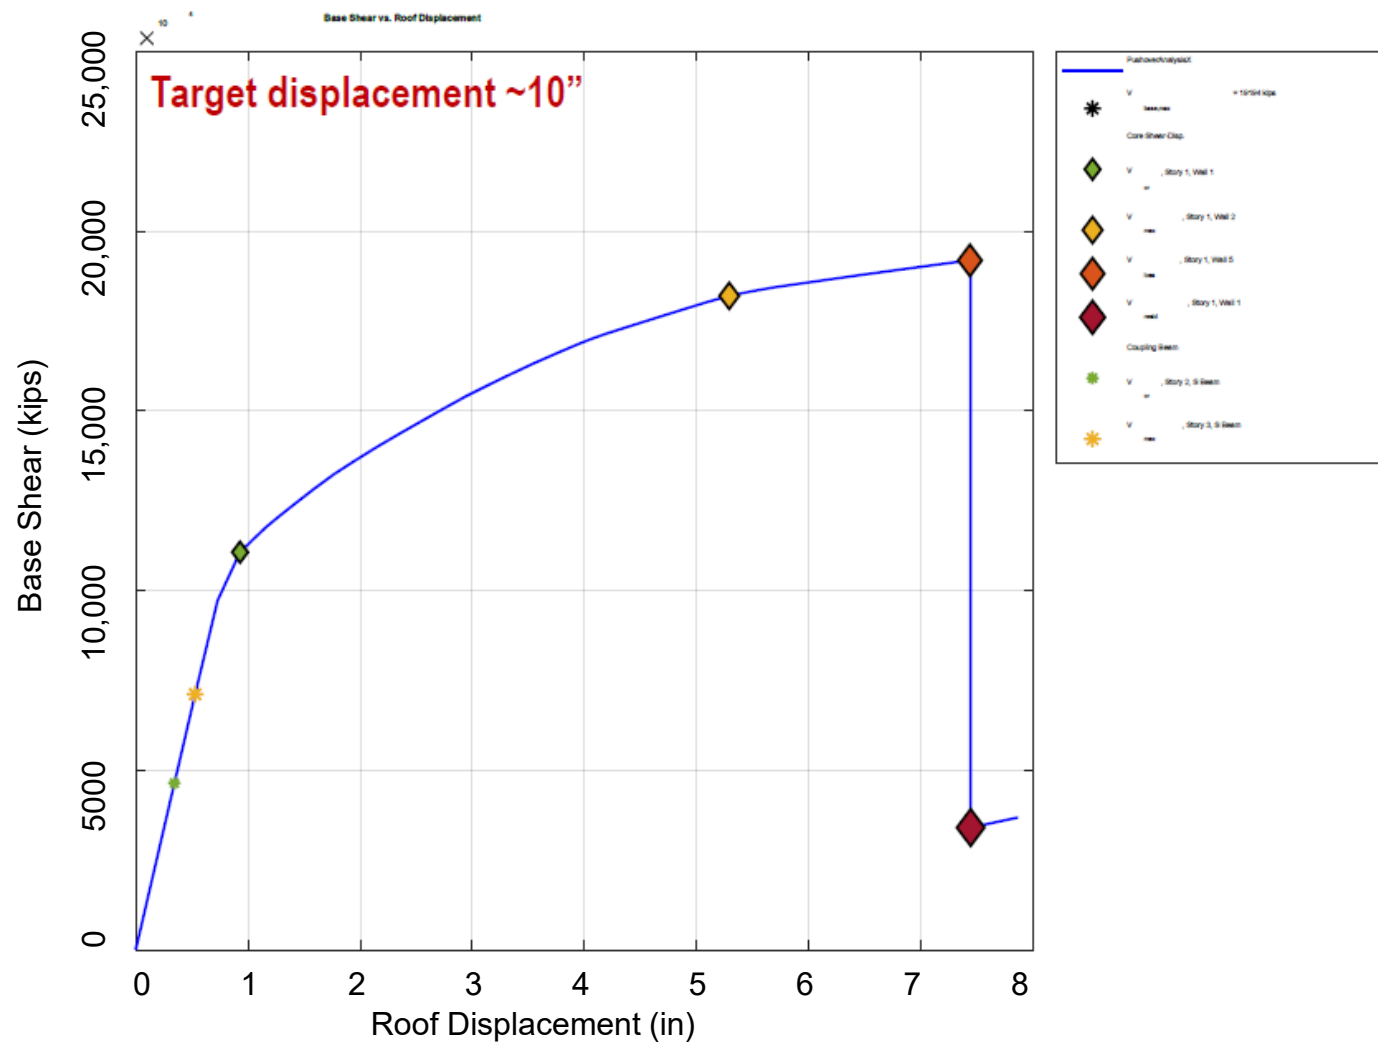
- Model shows “failure” when wall can no longer take shear force.
  - Limit specified by ASCE 41.
- This occurs at relatively low lateral deflection.
- Doesn’t mean the wall can’t carry vertical load.

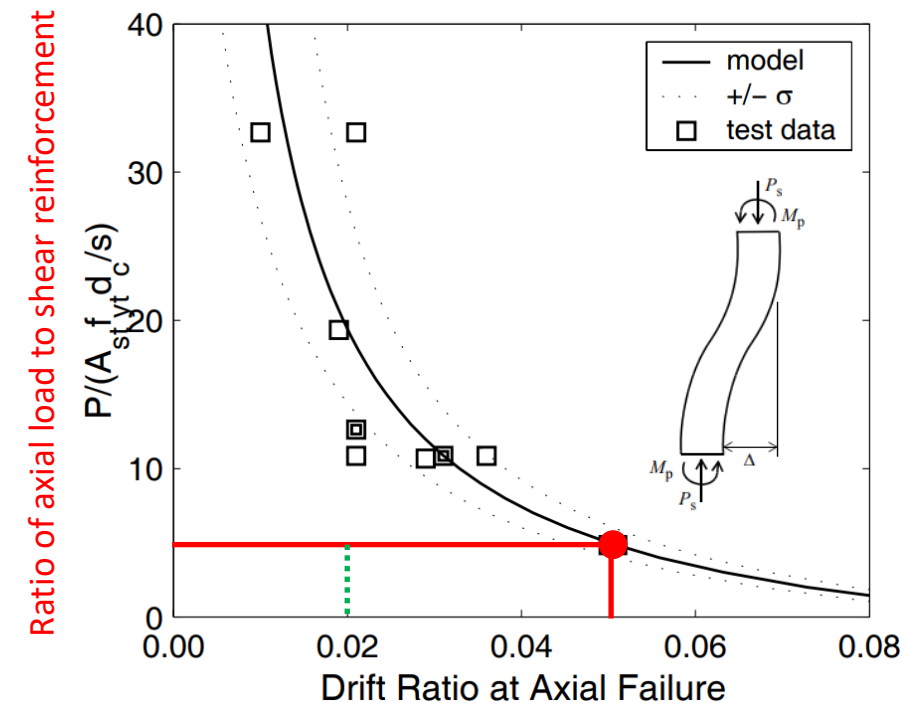
Lab testing to determine  
lateral deflection at collapse

- Complete shear failure in model at 2% drift.
- Collapse at 5% drift.
