# SP3 SITE SEISMIC HAZARDS REPORT

## Site Seismic Hazards Report

123 Main Street, San Francisco, CA

v15.0.0 of the SP3 Platform

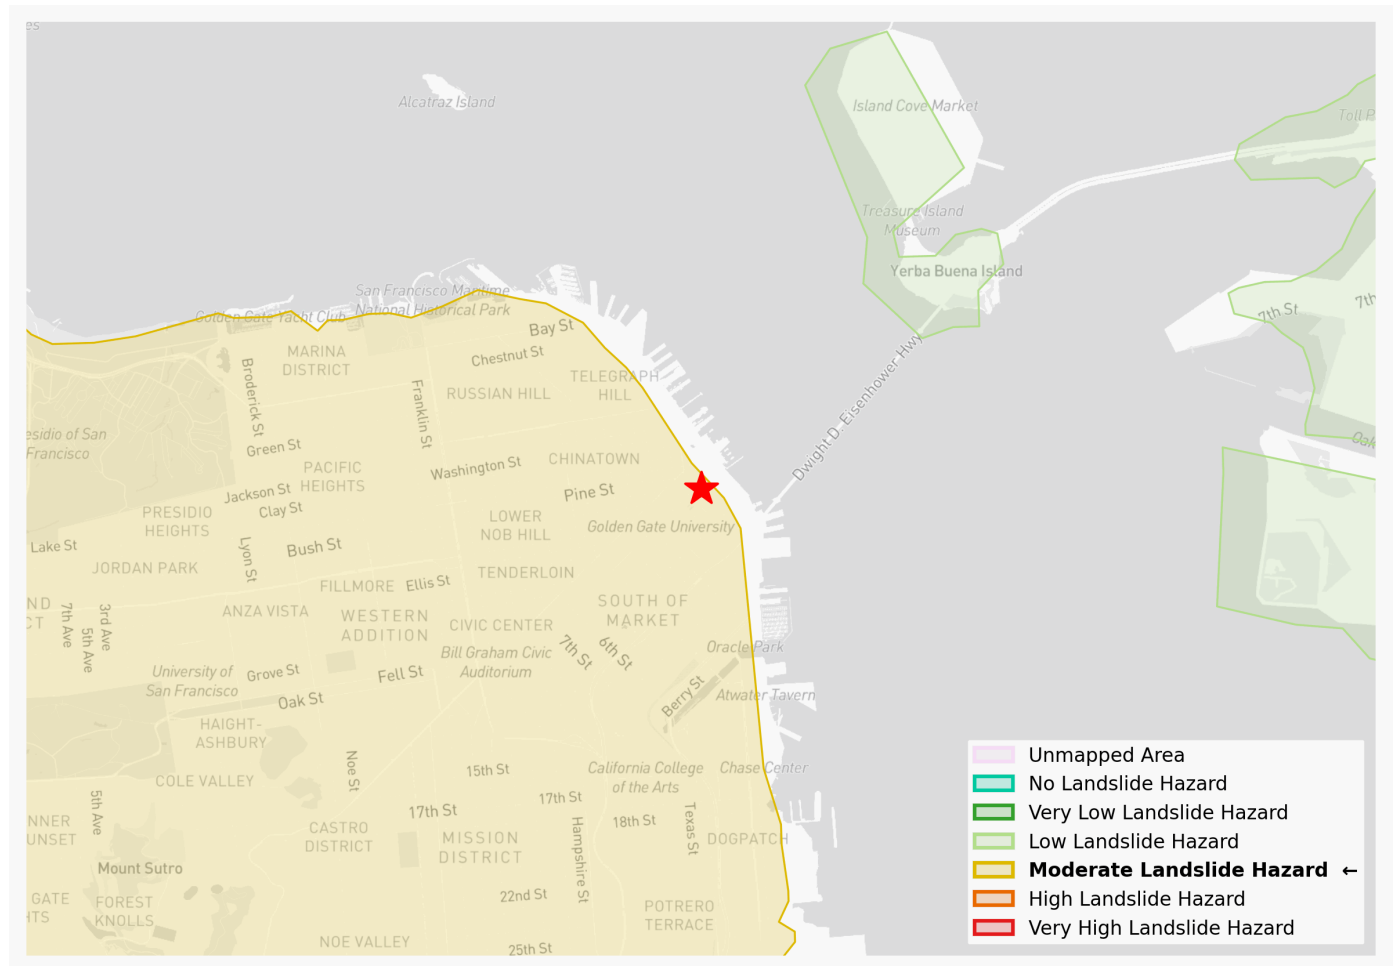
## 6.2 U.S. Geological Survey Professional Paper 1183, Landslide Overview

Based on the map below, this site is in a **Moderate Landslide Hazard zone**.

| 6.2 | U.S. Geological Survey Professional Paper 1183, Landslide Overview | Moderate Landslide Hazard |

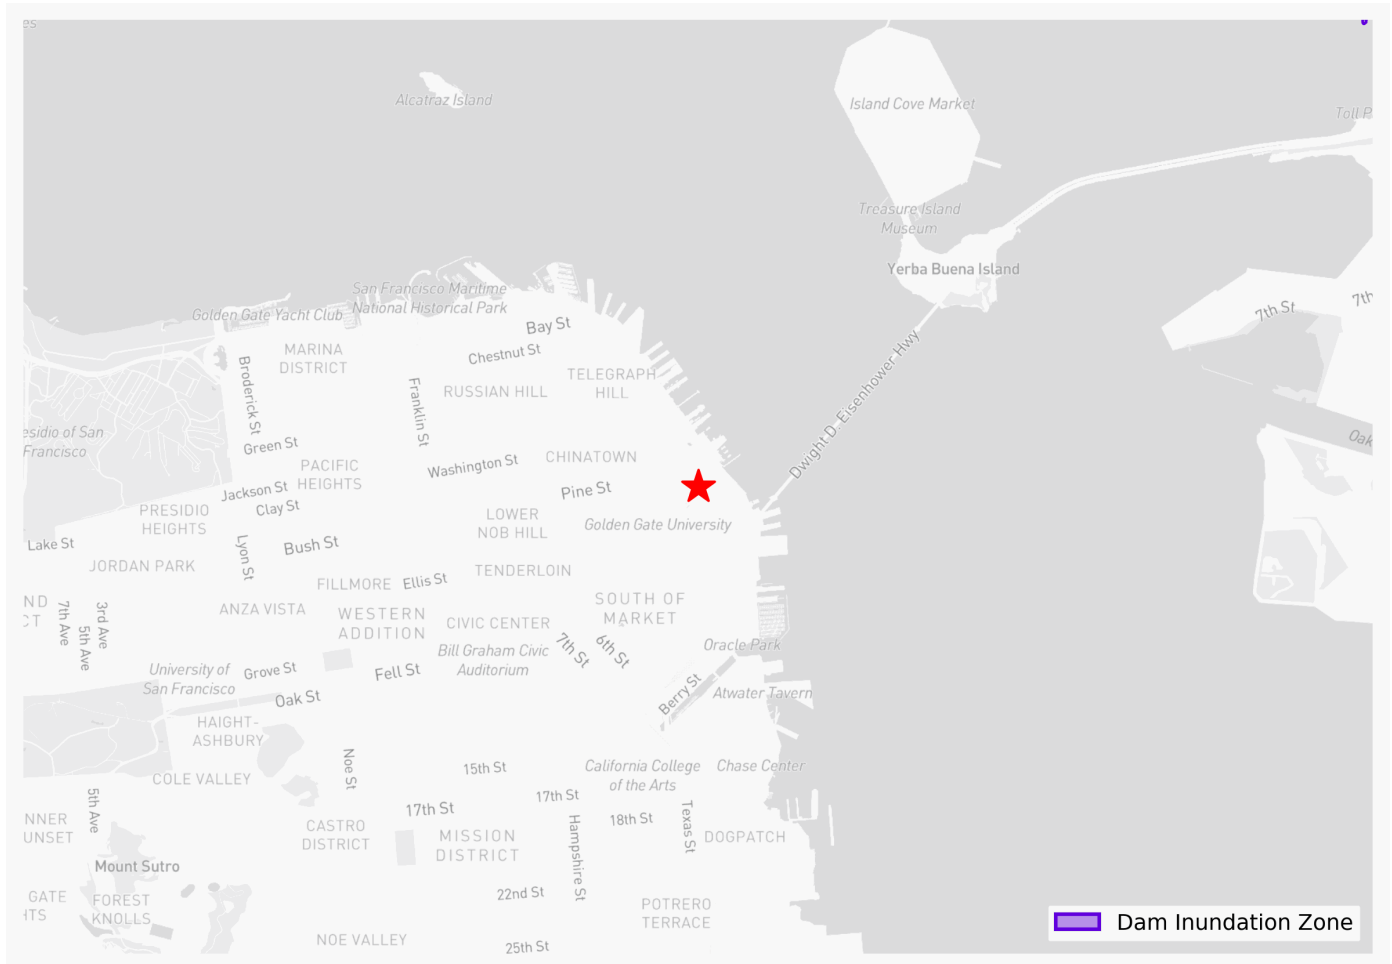
## 12.2 Temescal, Lake

An Inundation map shows flooding that could result from a hypothetical failure of a dam or its critical appurtenant structure.

Based on the map below, this site is **not in a mapped Dam Inundation zone**.
